**REPORT ON THE STATE OF  
PRESERVATION OF THE  
BYZANTINE DU MOSAIC OF THE  
MONASTERY OF SAINT GABRIEL  
TUR ABDIN, TURKEY**

**WORKSHOP ON THE  
PRESERVATION AND  
RESTORATION OF MOSAICS  
MISSION OCTOBER 10th – 14th 2008**

## Report on the state of preservation of the Byzantine mosaics of the Saint Gabriel Monastery of Qartamin, Tur Abdin (south-west Turkey)

October 10-14, 2008

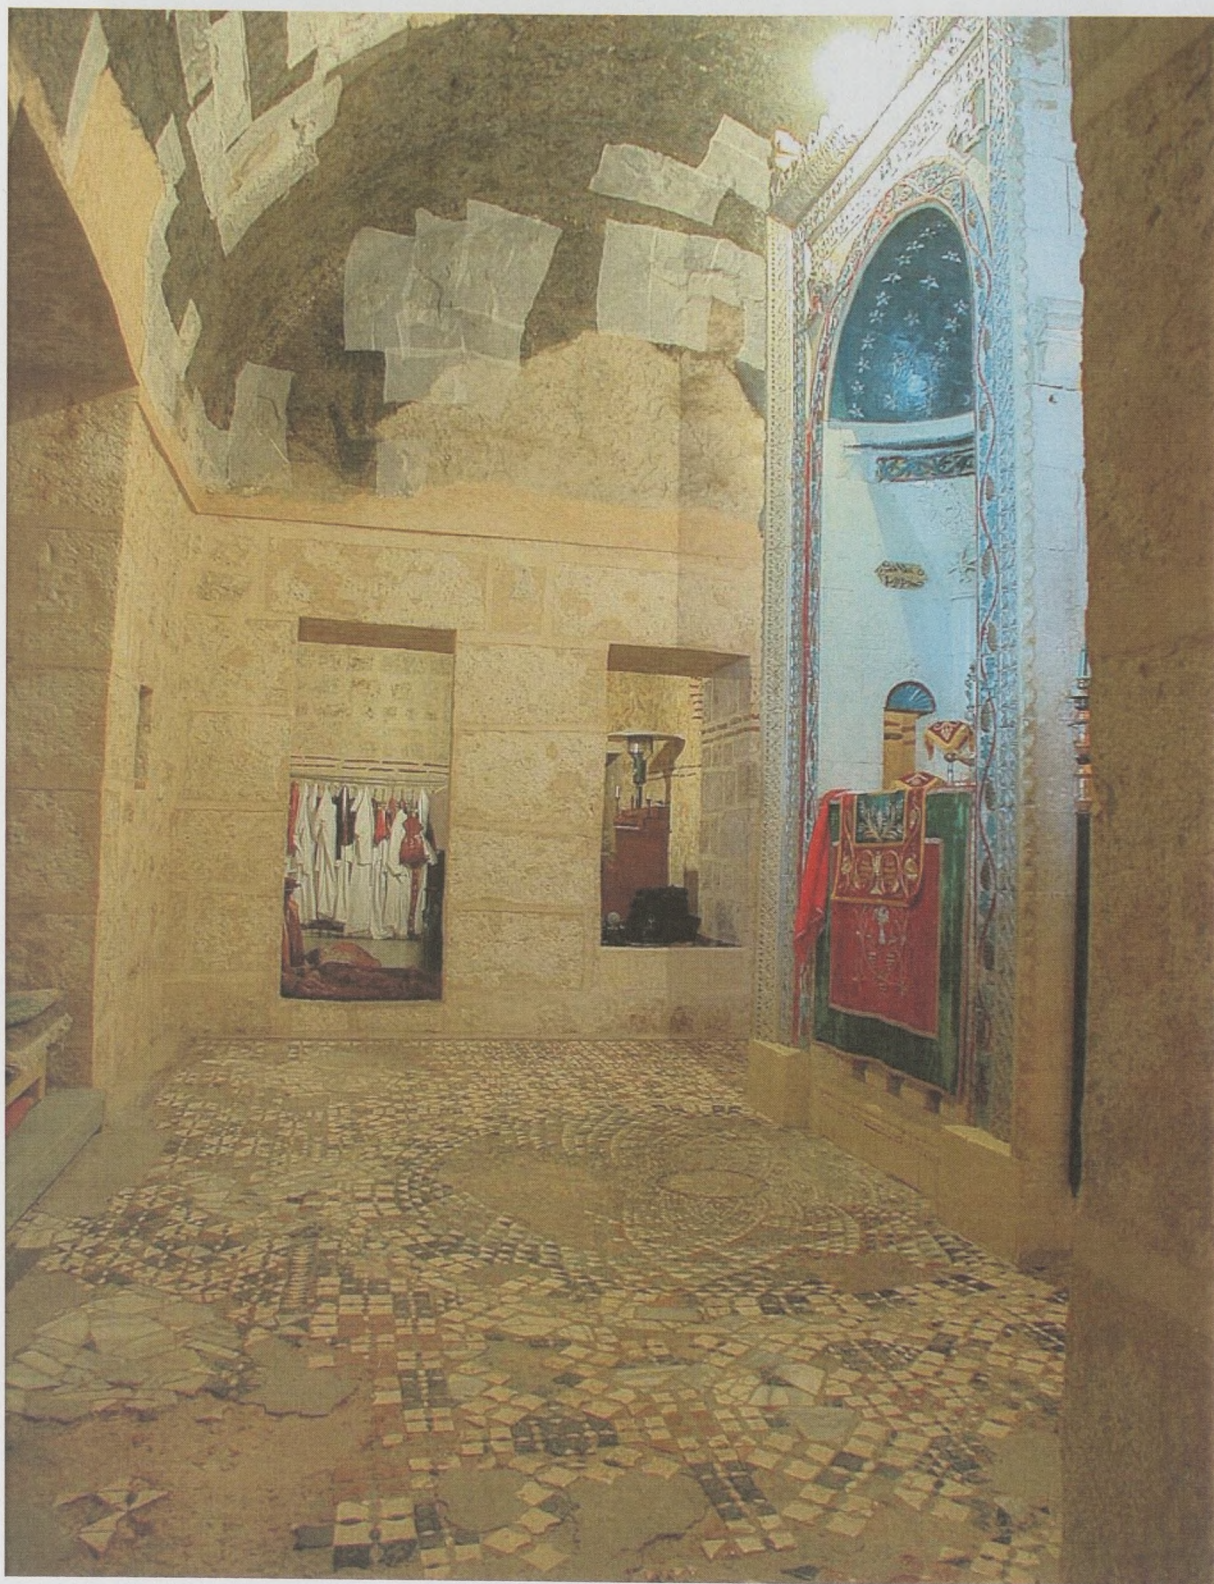
The main church choir of the Saint Gabriel monastery. The mosaics cover the vaulted ceiling and two lunettes; the floor is paved in *opus sectile*. During the twentieth century, an altar was erected in the center of the choir.

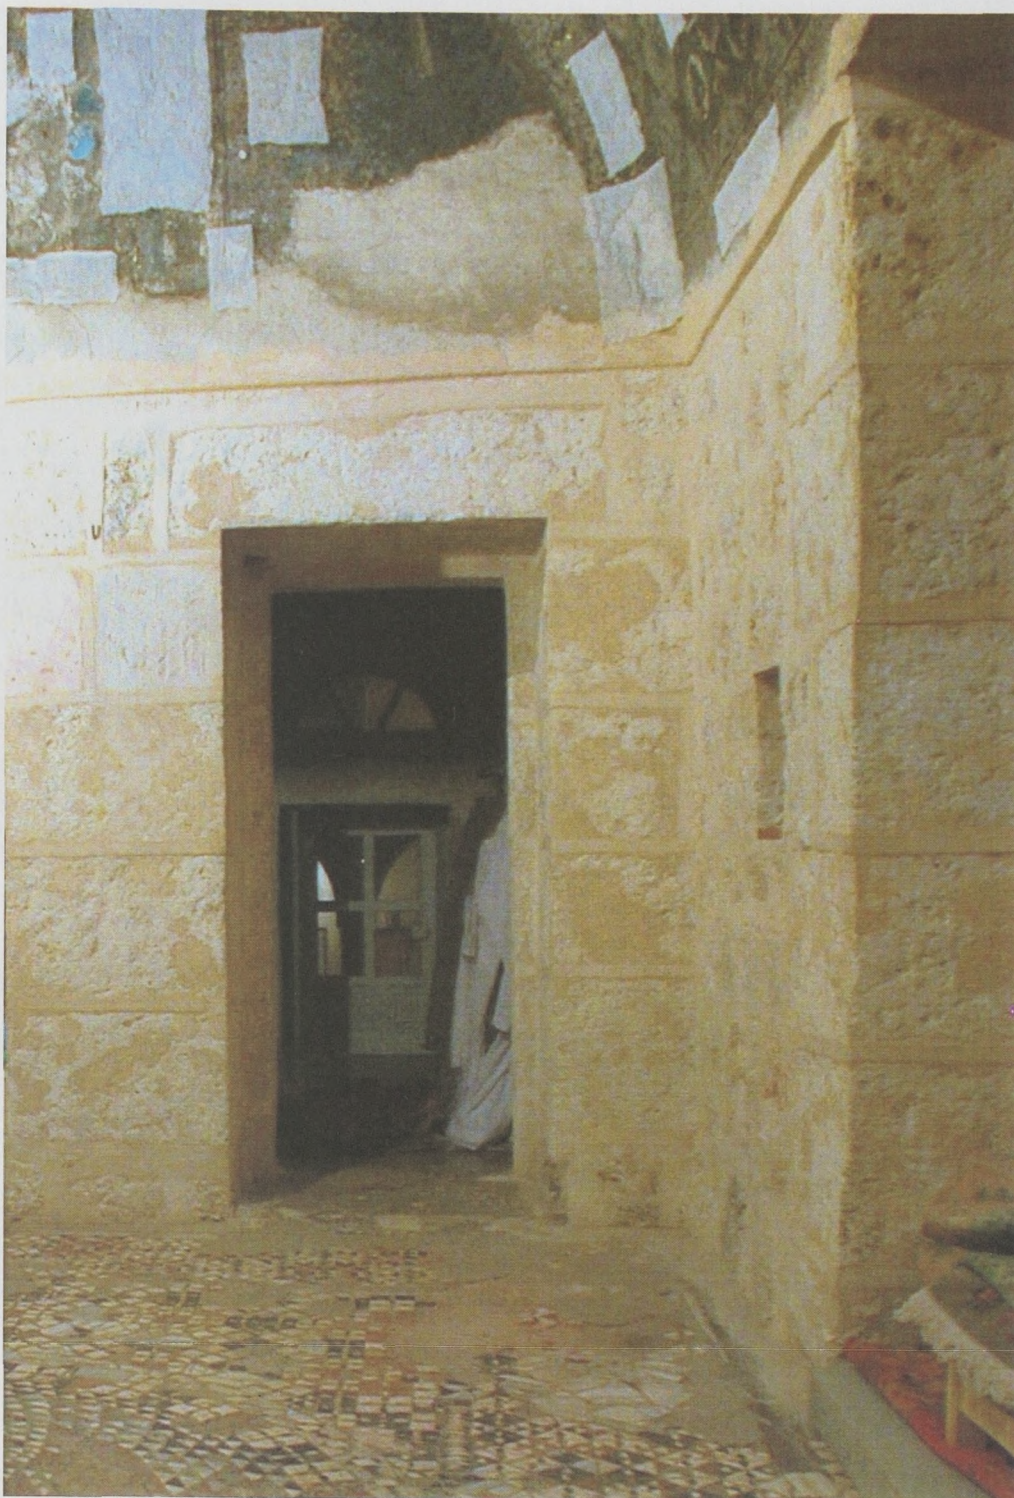
The interior of the church was entirely renovated in 1997. The stones were cleaned and pointed with cement mortar. No trace of ancient polychromic mural paintings or mortar remains visible today.

Despite his warnings, no serious conservation work seems to have been undertaken until 1997. At that time, the whole interior of the church was "restored", the walls were cleaned and all traces of the ancient coating was removed. The stones were bared and repointed with white cement mortar. This also seems to have been when the gaps in the mosaics of the vault's spring were plugged with beige mortar, underlining the vault's lower section. A comparison of the present state of preservation with the photographs Hawkins and Mundell included in their article reveals that tesserae have disappeared in places, especially in the southern lunette's inscription. The damage probably occurred in the course of this restoration work.

We are faced with architecture that was entirely renovated without concern for the materials used in the fifth century. The mortars used in ancient times were made up of a lime binder with a mineral mixture (sand, terra cotta, gravel) which let water vapor through. Since it was not hard, it possessed a certain elasticity that allowed it to give without breaking. This is not the case with the modern cement mortars, waterproof and very hard, that were set in place in the twentieth century. Overly hard compared to the ancient materials, they are already detaching.

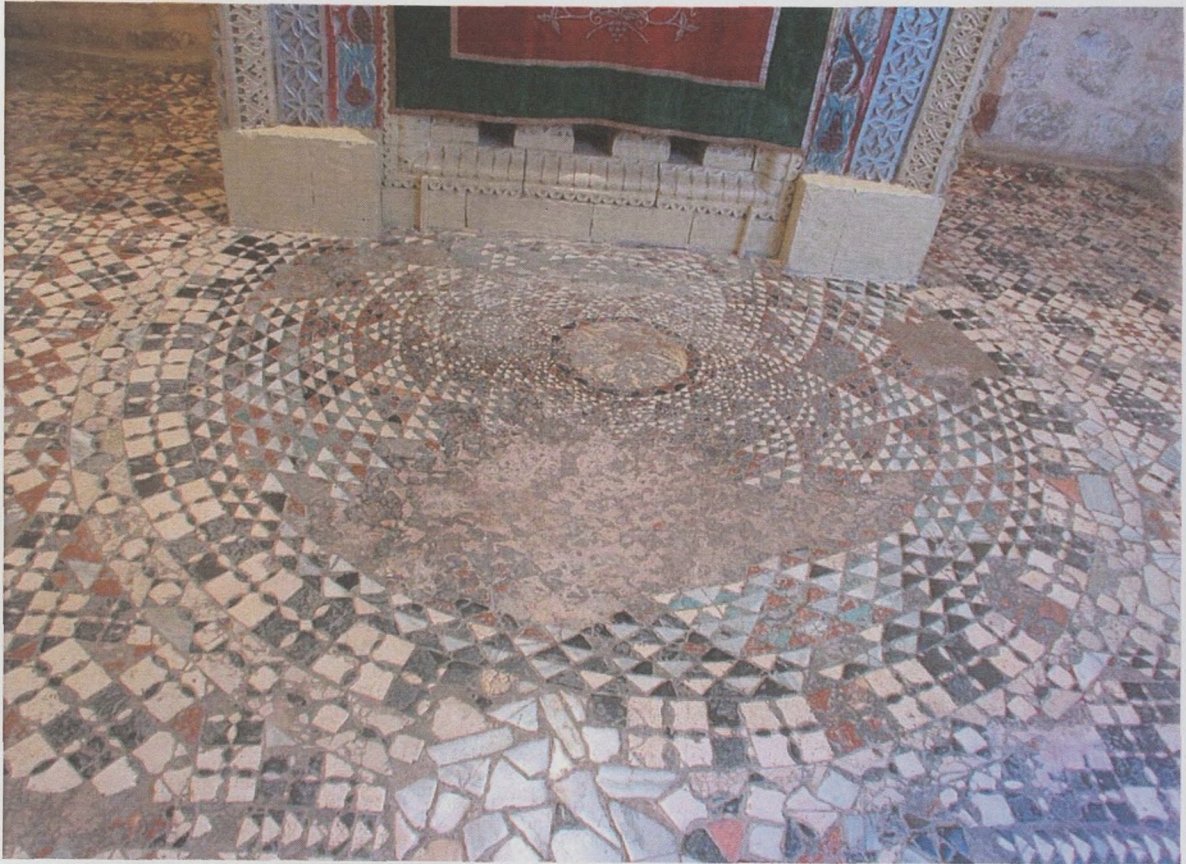
The ancient *opus sectile* floor is preserved over the entire surface of the choir.

In the very irregular *opus sectile* flooring, ancient restorations are still visible. These restorations were carried out using grey cement and scattered marble fragments. Though the marble pieces remain in place, several parts have cracks that show the ancient mortar. The floor is normally covered with carpets which have also served to protect it.

As for the *opus sectile* floor, it would be preferable to clean it, to replace the grey cement mortar with a limestone mortar similar to the ancient composition, and to reinforce the areas of ancient mortar. This operation is not included in the estimate listed below.

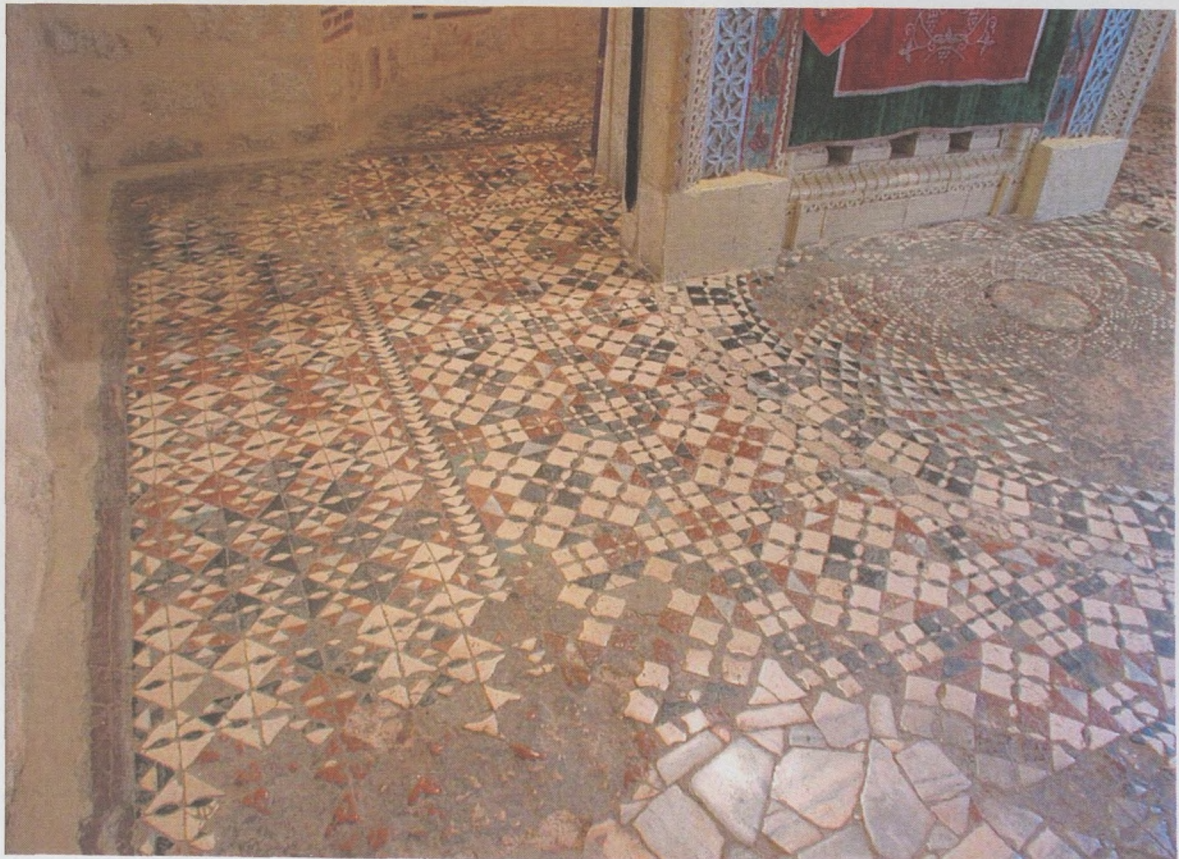
The modern altar seems to stand on *opus sectile*.

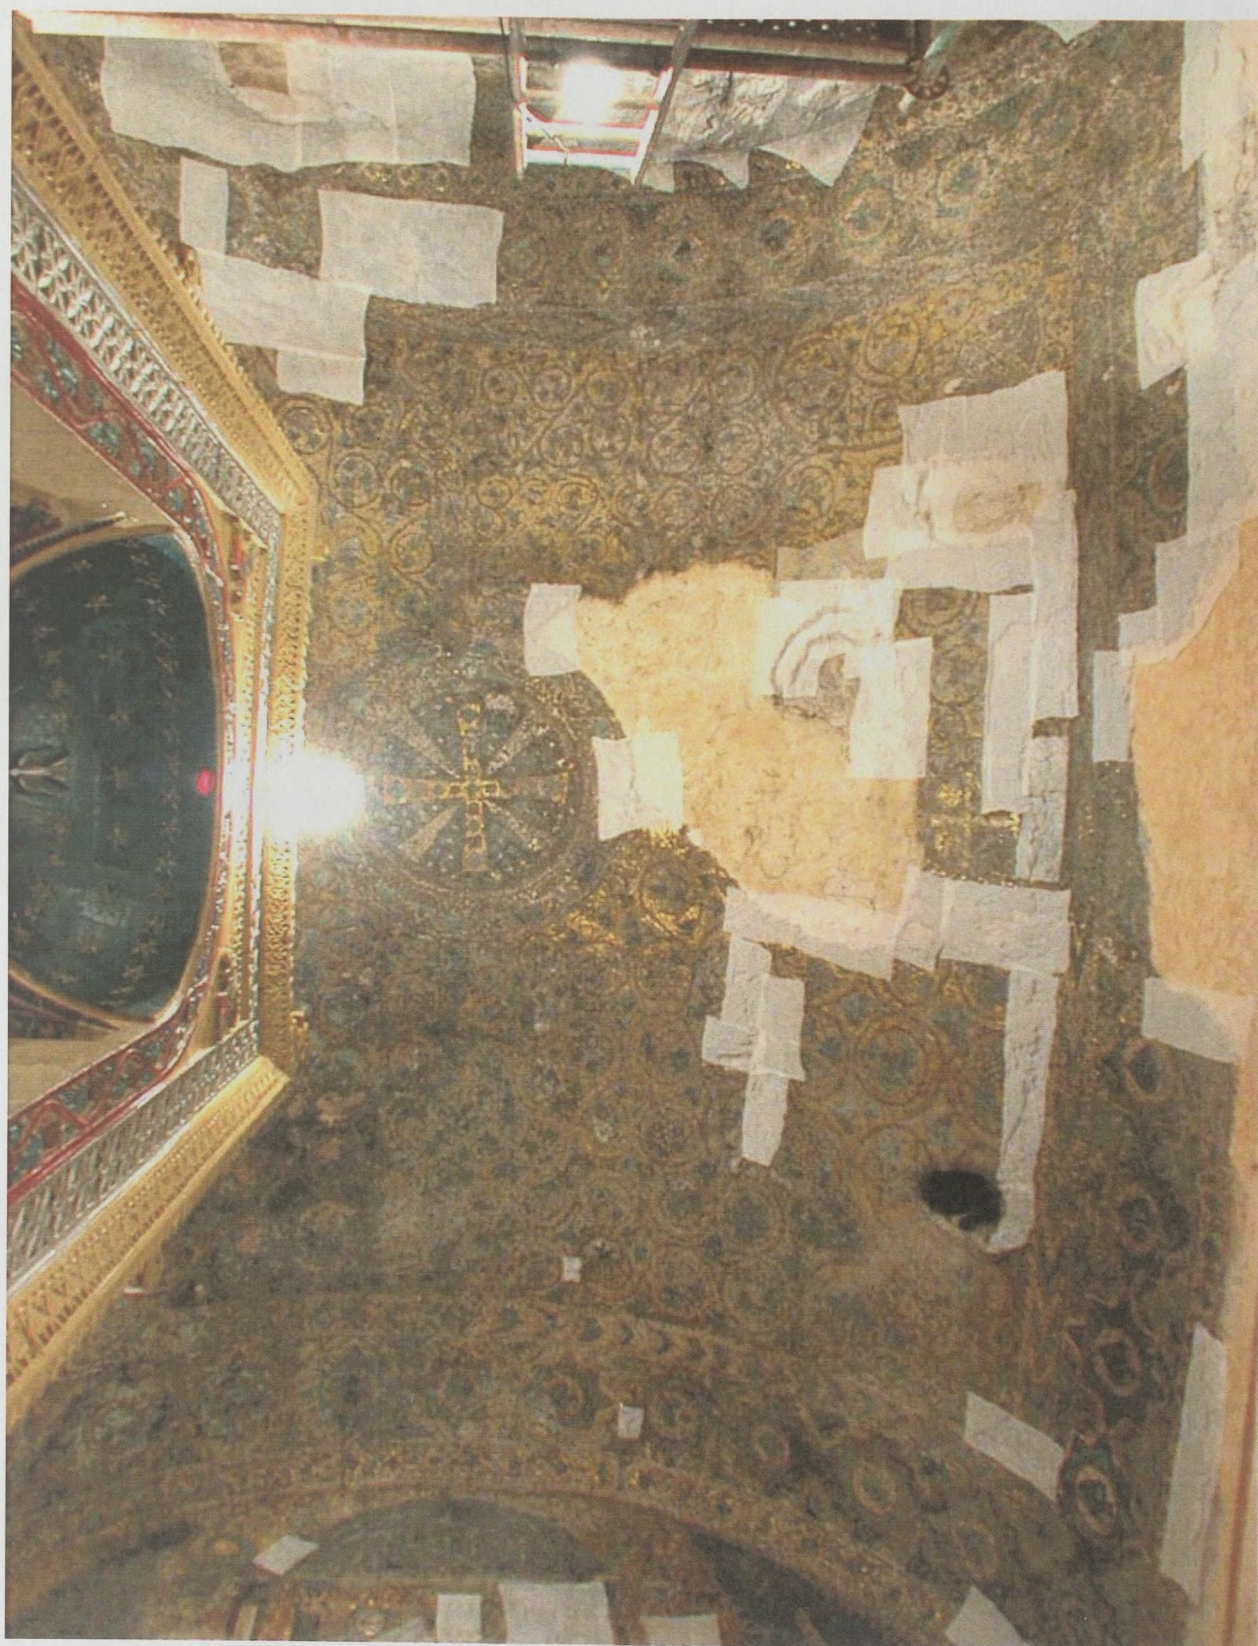
The present state of the mosaic preserved on the ceiling.

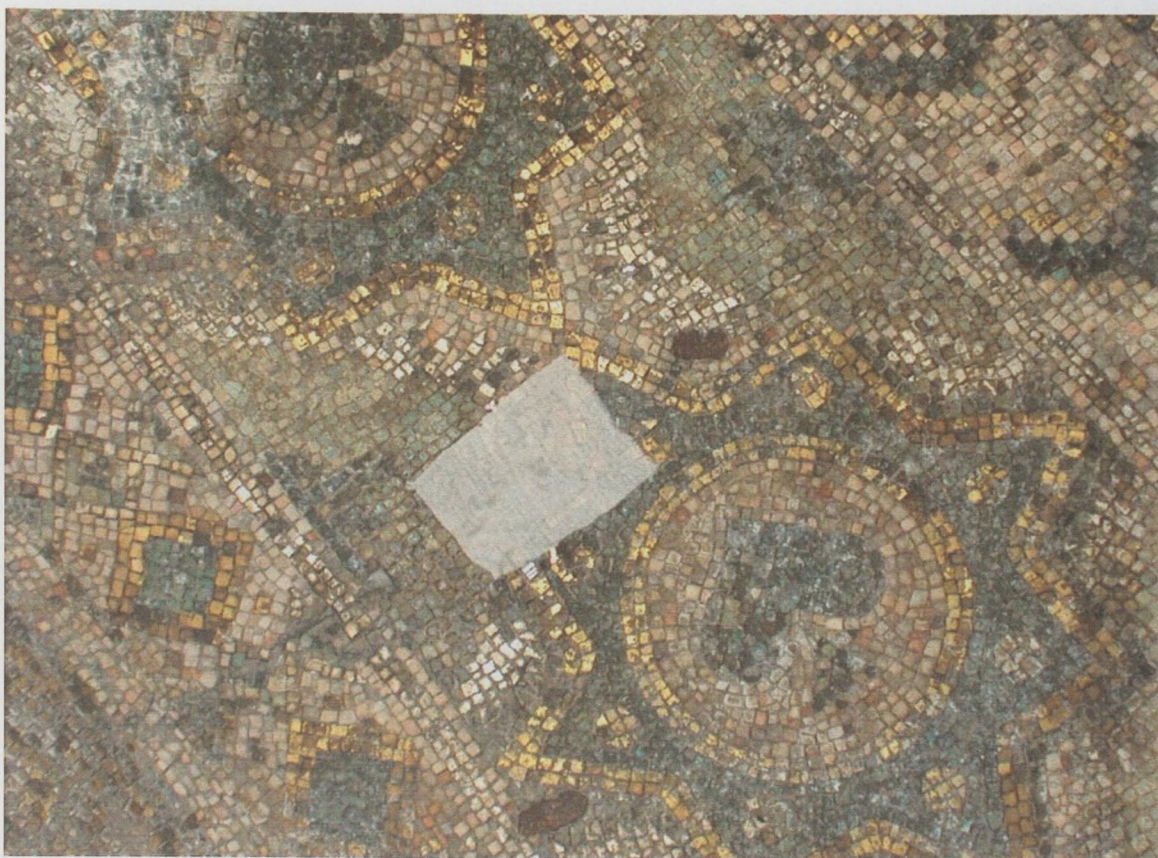
On the ceiling, we noted the presence of metal clamps stuck into the mosaic, flush with the tesserae's surface. These hooks reinforce the mortar's hold on the wall. Because of the general sootiness and our limited time, we were unable to check the regularity of their placement. A list will have to be drawn up, and a more detailed study will need to be conducted of the metal's state of preservation. Depending on the results, it may be necessary to replace them.

Metallic clamps in the ceiling's mosaic.

It will be necessary to discover the extent to which the metallic clamps have oxidized. The products of metallic corrosion can crack mortar and also cause discolorations to

the tesserae and mortar. If this is the case, it may be necessary to remove them and replace them with clamps of non-oxidizing material.

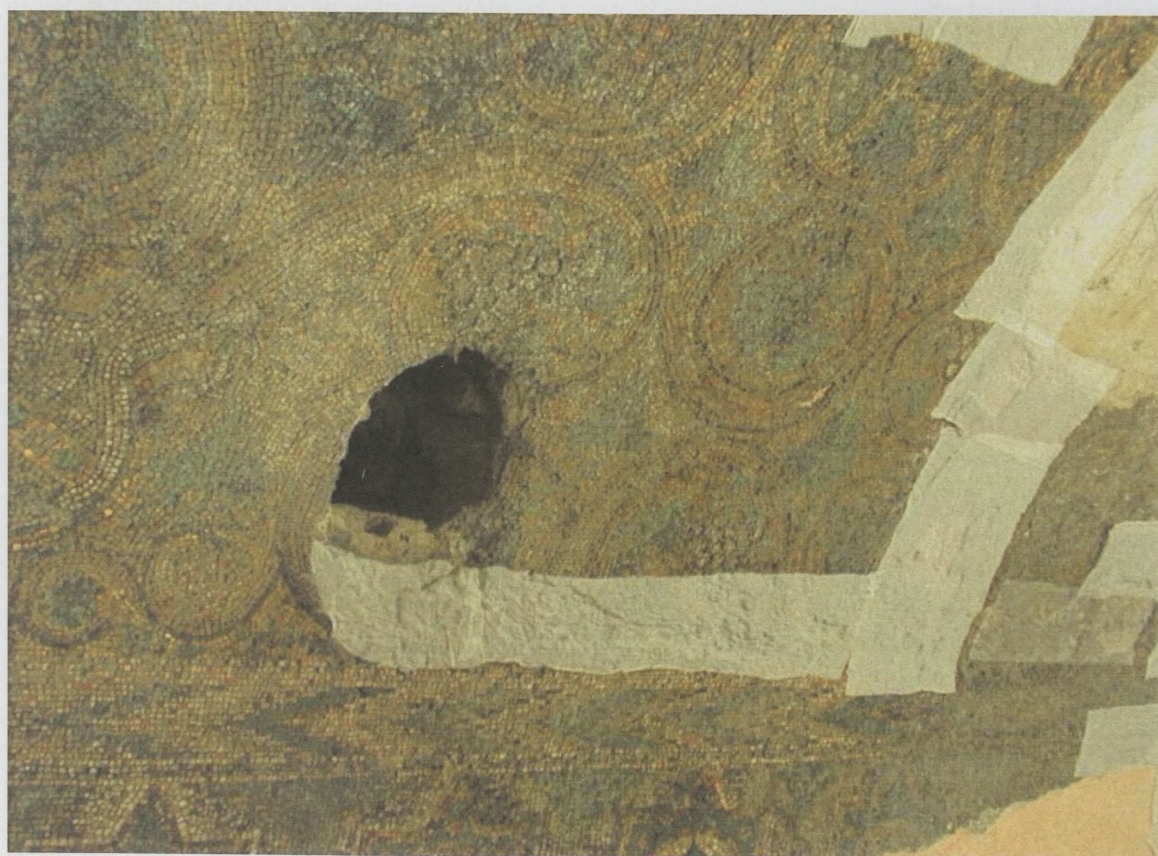
On the ceiling's western spring, a large hole is visible in the interior of the structure, in the mosaic and its mortars as well as in the wall itself, but a corresponding hole was not found on the ceiling's exterior. It is most probably the opening for a conduit whose function we were unable to ascertain. The mosaic and its mortar incline slightly into the conduit, proof that the conduit already existed when the mosaics were being laid.

Opening for an ancient conduit in the ceiling.

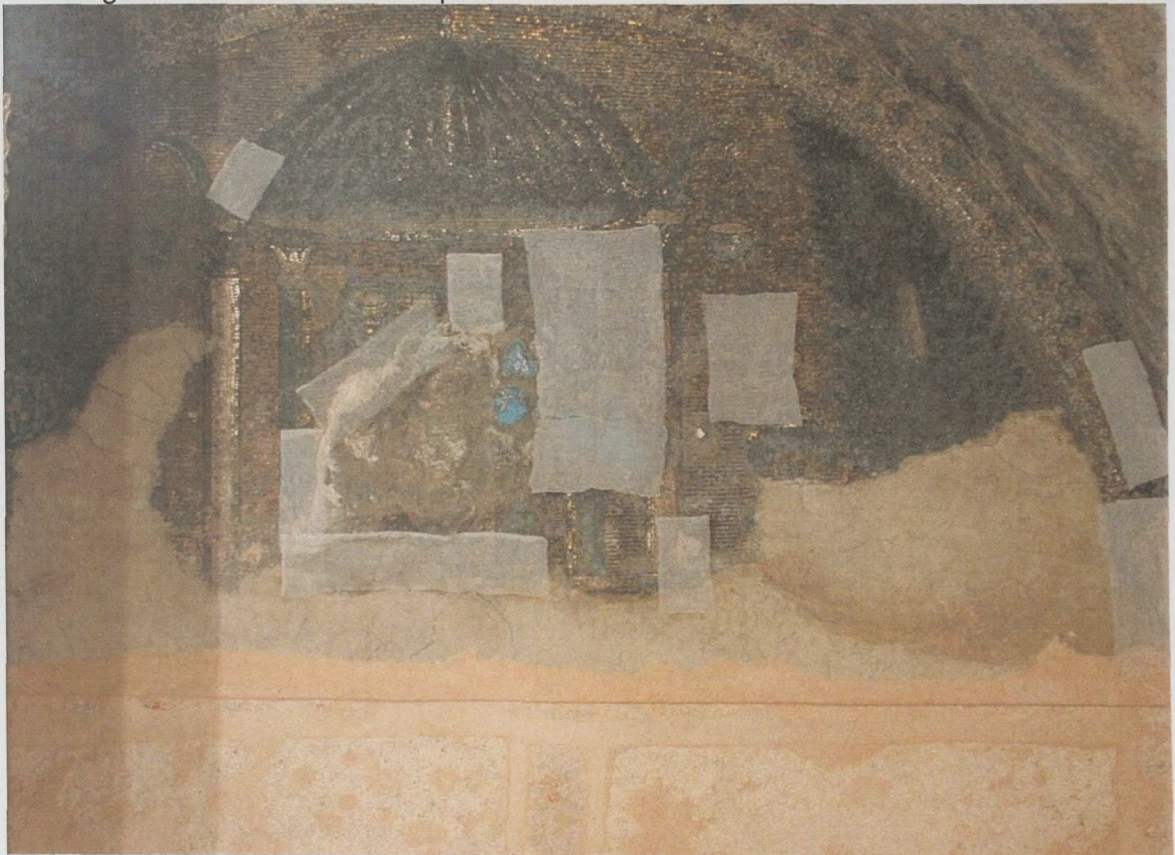
In the south lunette, the lower section has many lacunae, and is plugged with the grey cement mortar seen already in the photographs Hawkins and Mundell took in 1972. This cracked mortar no longer sticks to the wall. In the center of the pictured tabernacle, an older crack was filled with glazed blue ceramic elements (already

The decor is cracked. During a previous restoration, enamel tiles fragments were set into the plugging mortar.

In the lacunae, the cement mortar—cracked and loose, as well as unseemly—will have to be removed by mechanical means. In order for the cracks to be cleared out, the fragile areas, and especially the mosaic's edge, will have to be held in place by a textile paste.

Lime mortar will be set into the fissures; this will be close to the ancient mortar in both graininess and color. It will be set slightly recessed from the mosaic's surface in order that it may be easily identified.

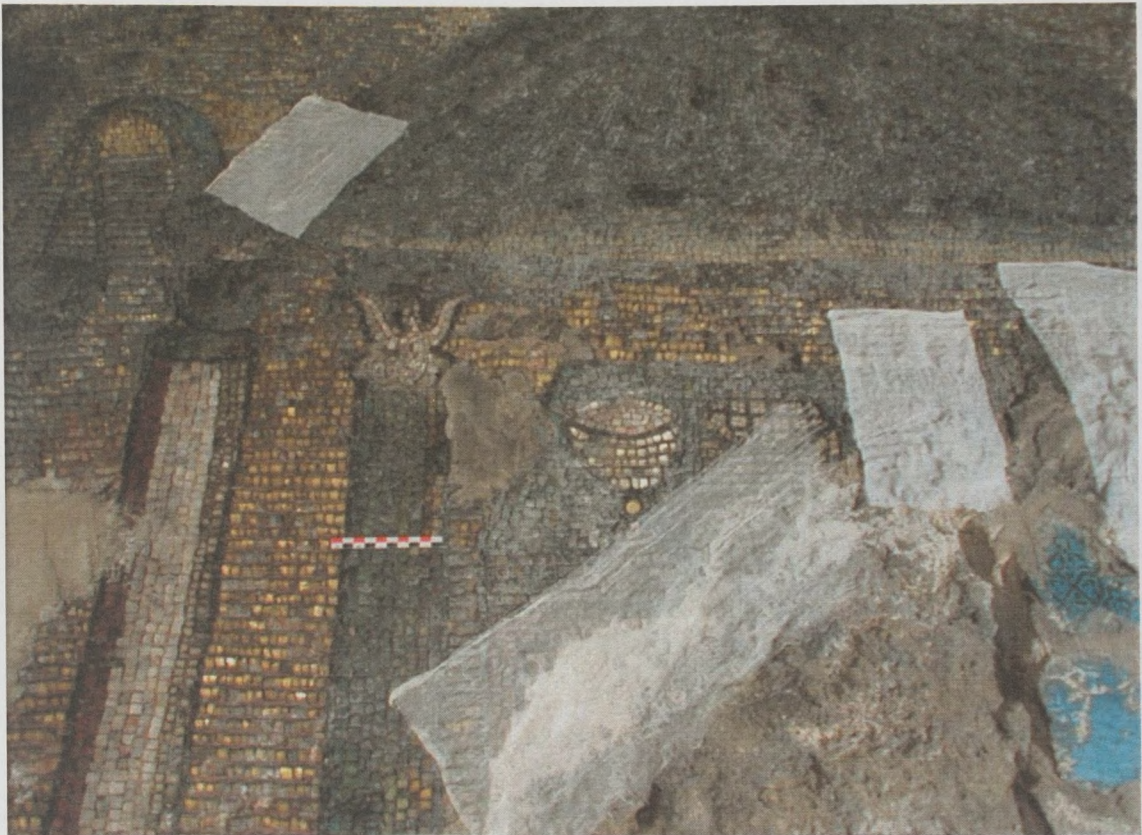
Detail of the state of preservation, and of the iconography.

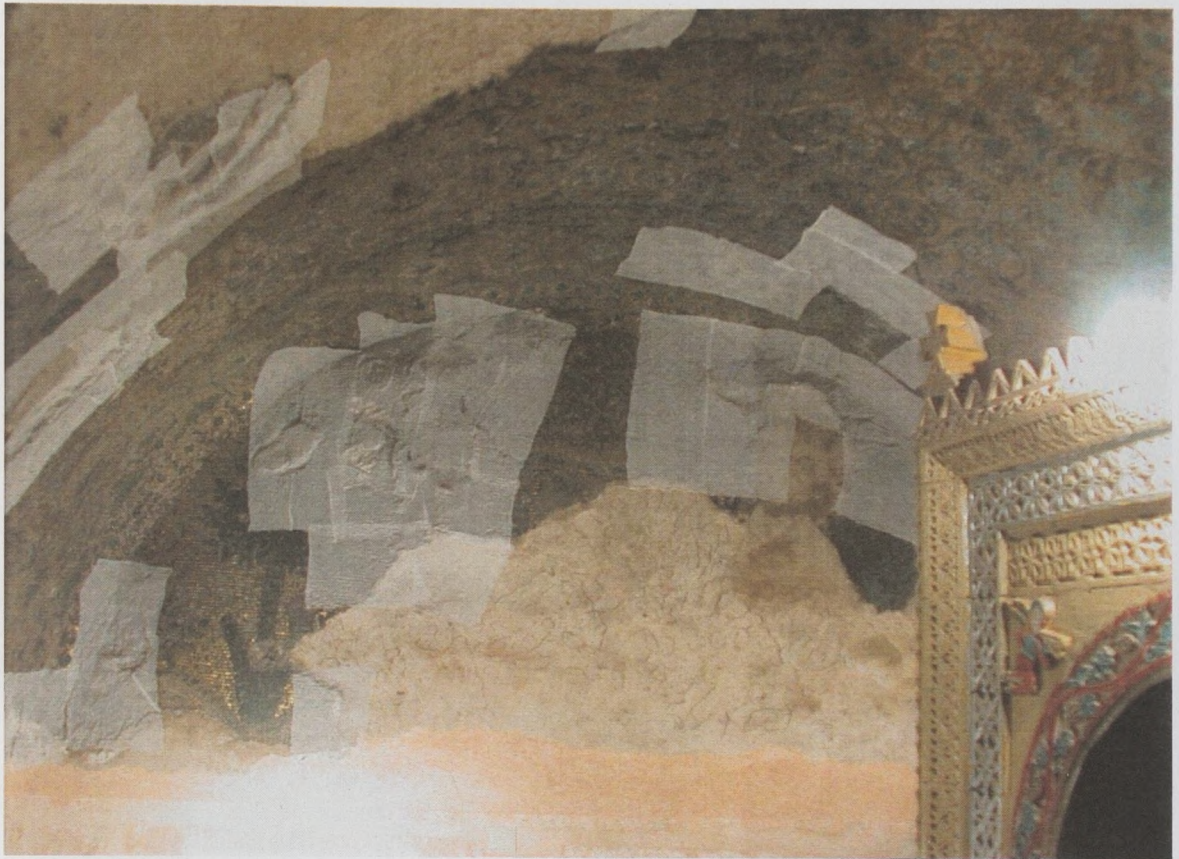
By comparison with the earliest illustrations, one can see that the north lunette is much more damaged, and a large section of the west side has detached, which is already visible in the single photograph that we possess of the ceiling, taken in 1911. The cracks have been plugged with the same sort of grey cement mortar. However, though the mosaic seems to have shifted only slightly since Hawkins' stay, all of the mosaics contained in this lunette are in utter decay.

In the north lunette, more damaged, the decor is similar. Flanked by trees, a tabernacle with a scaly dome is supported by columns.

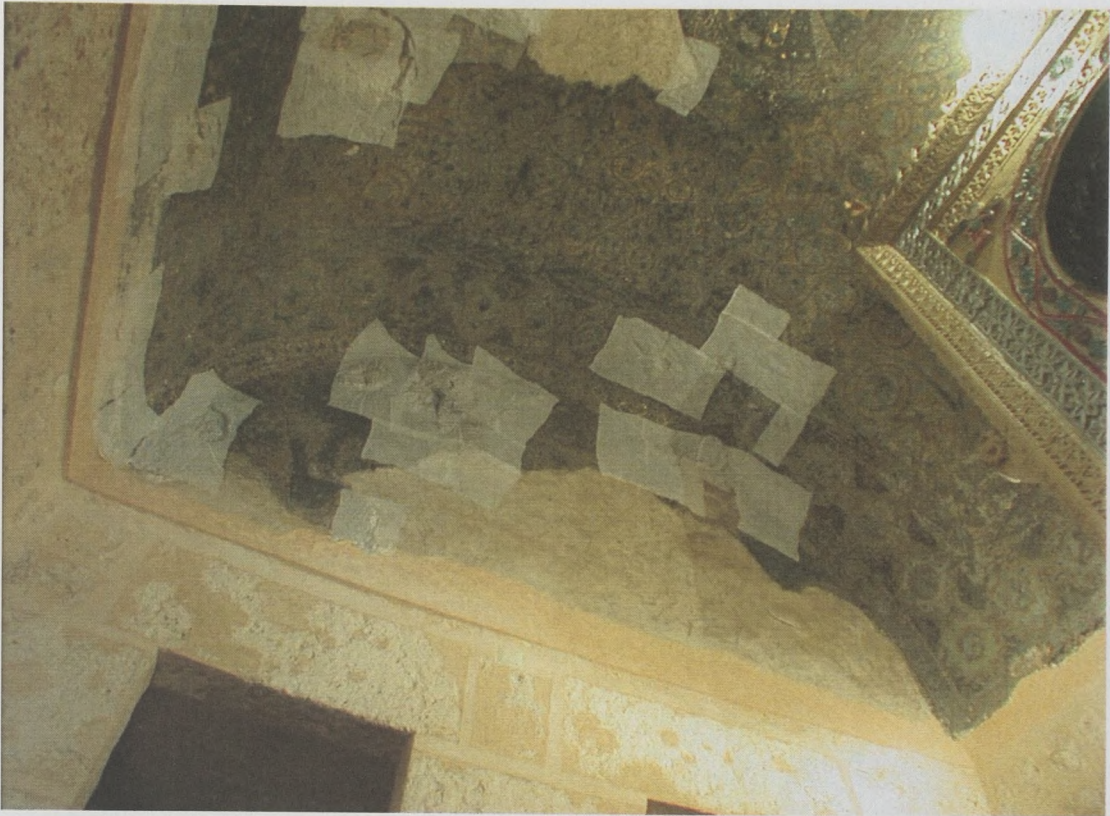
The ceiling also shows cracks: one large crack above the doorway leading in from the central nave, on the western arch, already visible in G. Bell's photograph; another large crack above the apse and behind the modern altar—this crack was plugged, probably in 1997, with a beige mortar similar to the one that borders the vault's spring; besides those, there are numerous smaller cracks, which are old and sooty. Our examination of the vault showed that even if the mortar is barely sticking to the stone, the tesserae are at least satisfactorily adhering to their mortar.

In 1997, the church was renovated; the lower part of the vault was edged, and cracks were filled with beige mortar. The grey cement fillings are older (before 1973).

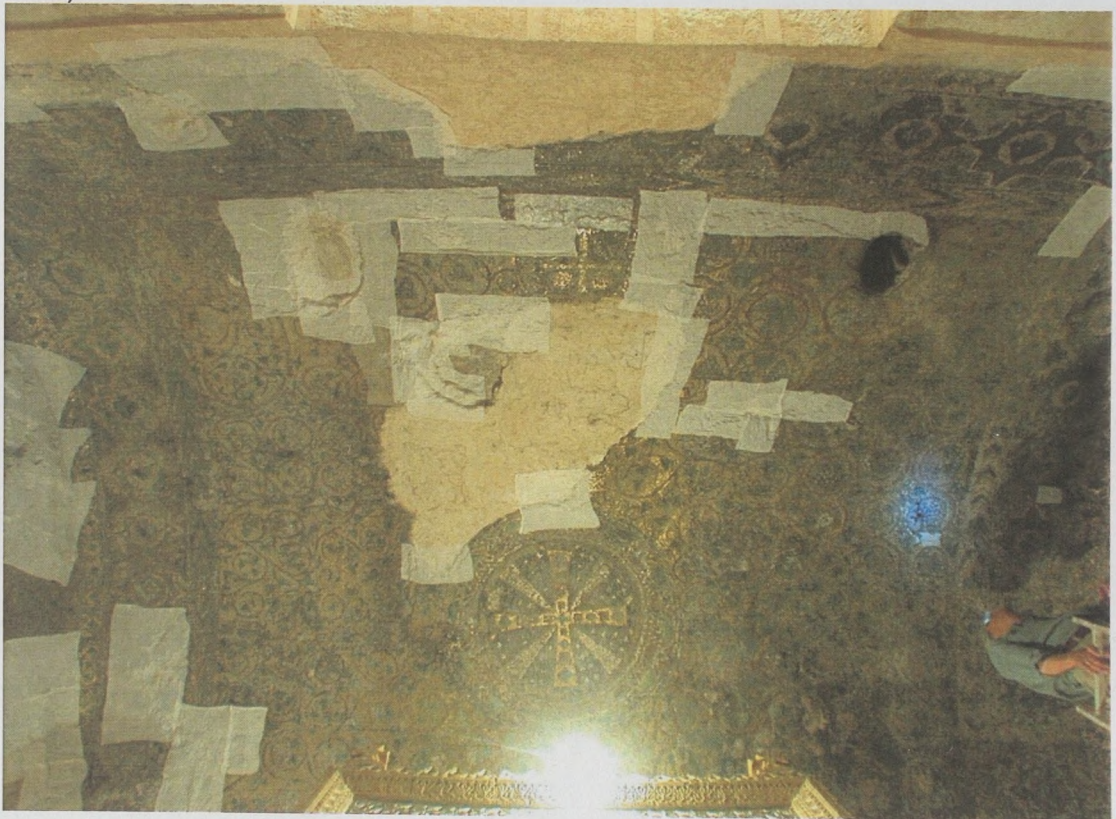
More recently, in 2001 or 2002, the region's governor called in a team of Italian restorers who were working on mosaics found during emergency excavations conducted because of the construction of a dam on the Euphrates, which flooded part of the ancient city of Zeugma. This team's work lasted two days, and consisted of gluing a layer of gauze to the mosaic to maintain the most weakened sections of the ceiling and lunettes. This gauze is still in place.

Gauze sheets were placed on the most fragile areas in 2001 or 2002.

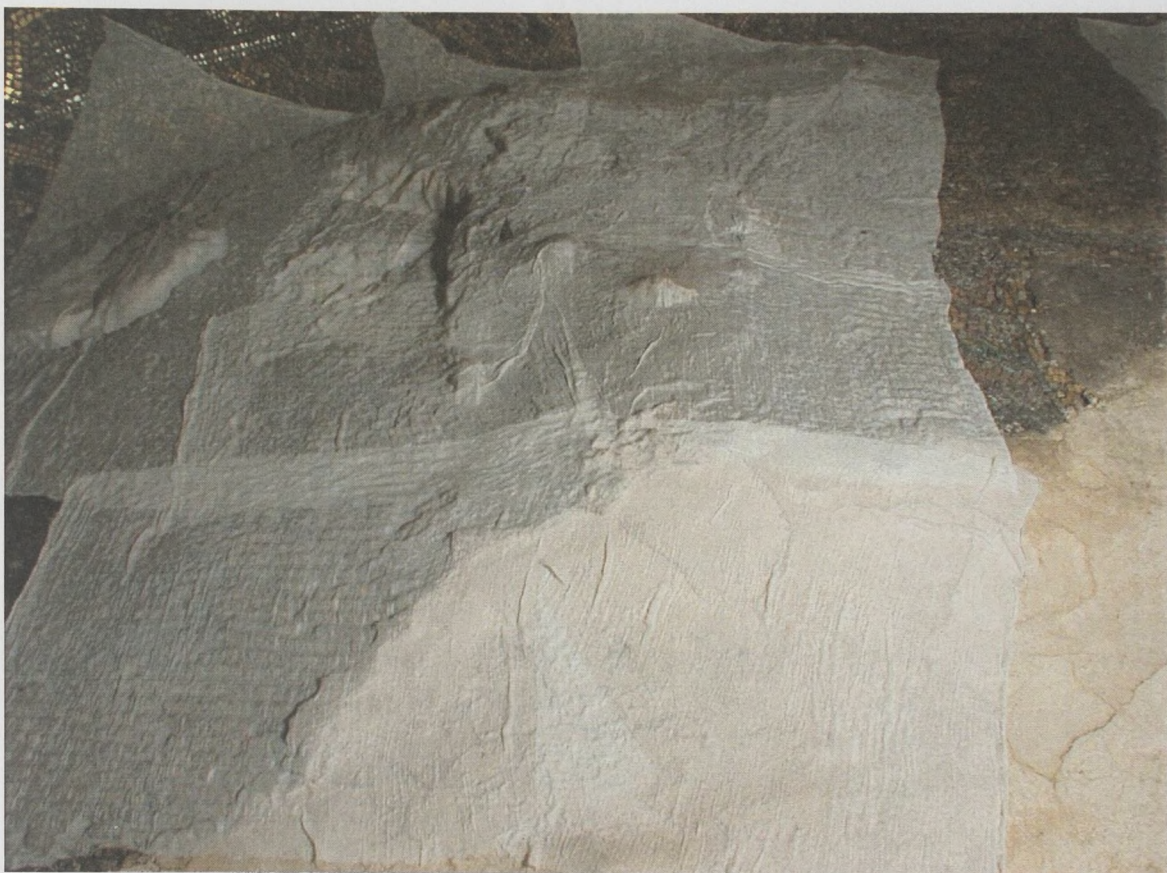
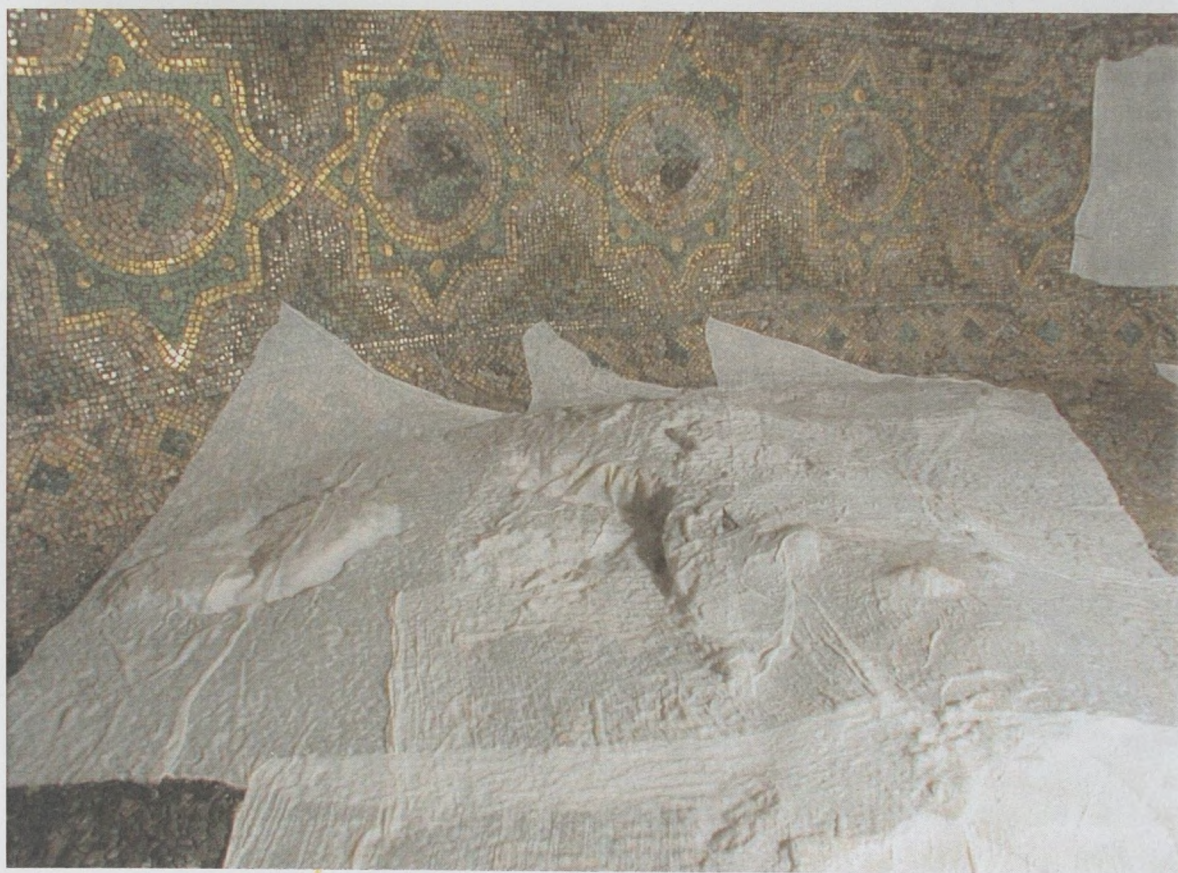
However, our examination brought to light graver damage, very worrisome unless action is taken quickly. In many places, the stone and brick masonry has detached from the first layer of gross mortar. This has taken place both in the north lunettes and on the ceiling. This detachment may cause large chunks of the mosaic to fall, particularly in light of the region's vulnerability to seismic activity and aftershocks. The Italian team recently called in reinforced many of the detached parts, but this can only be a stop-gap measure until true restoration work can be undertaken.

These cotton gauze sheets hold in the buckling areas, here in the north lunette.

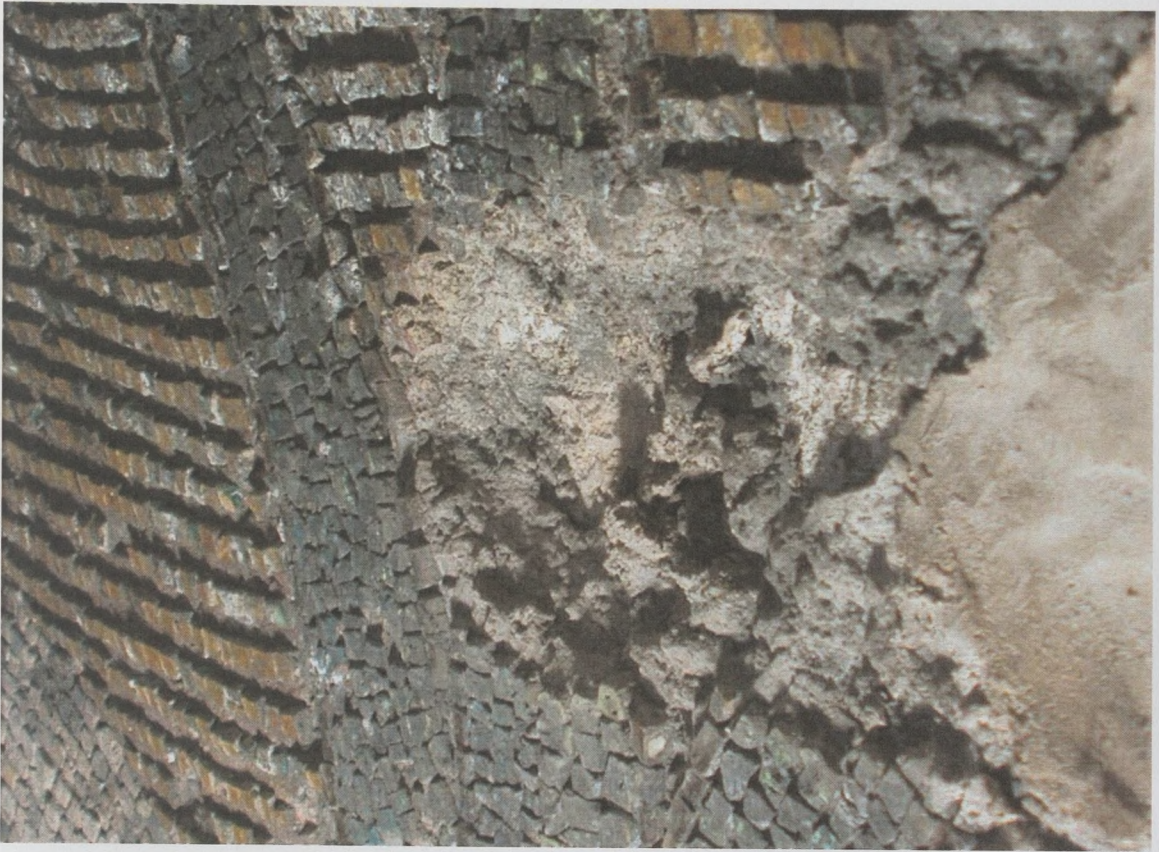
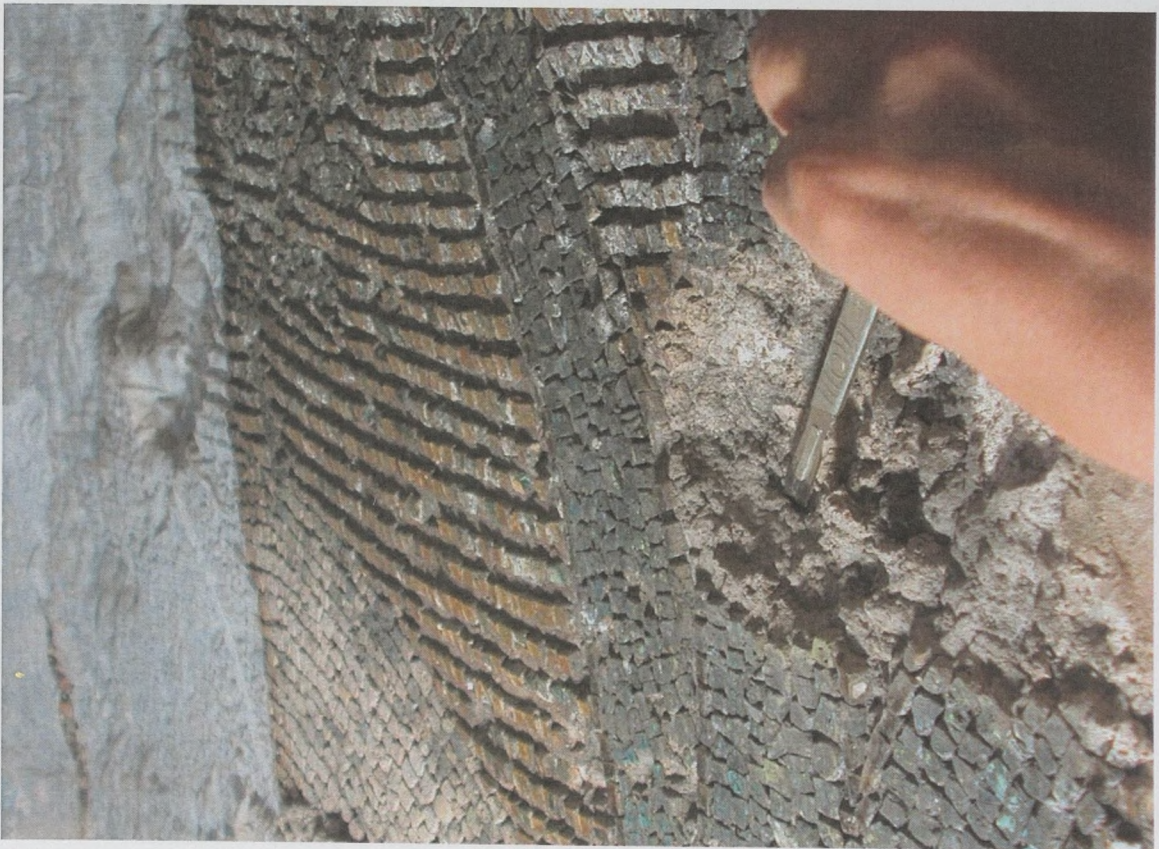
The tesserae's adherence to the mortar is satisfactory. But on the other hand, there is a general lack of adherence of the mortar to the wall (here in the north lunette). This long-standing problem may be accelerated if the renovation work breaks the masonry's hygrometric balance between the exterior and the interior.

At the same time, it is imperative to conduct a general reinforcement of the whole in order to reaffix the loose mortar to the stone walls. Before this can be done, the detached areas will have to be cleaned of accumulated mortar residue; this cleaning will be carried out by vacuum suction. Next, reinforcement will be conducted by injections of a lime mortar grout, followed by the placement of a prop and clamps to hold the mortar and the mosaic to the walls until it dries.

Certain small areas of the mosaic and mortar are no longer adhering to the walls. They are detached from the mosaic by fissures. After being pasted with textiles, they will be taken down; the crumbling mortar will be removed and each fragment will be set back in place on a new layer of lime mortar.

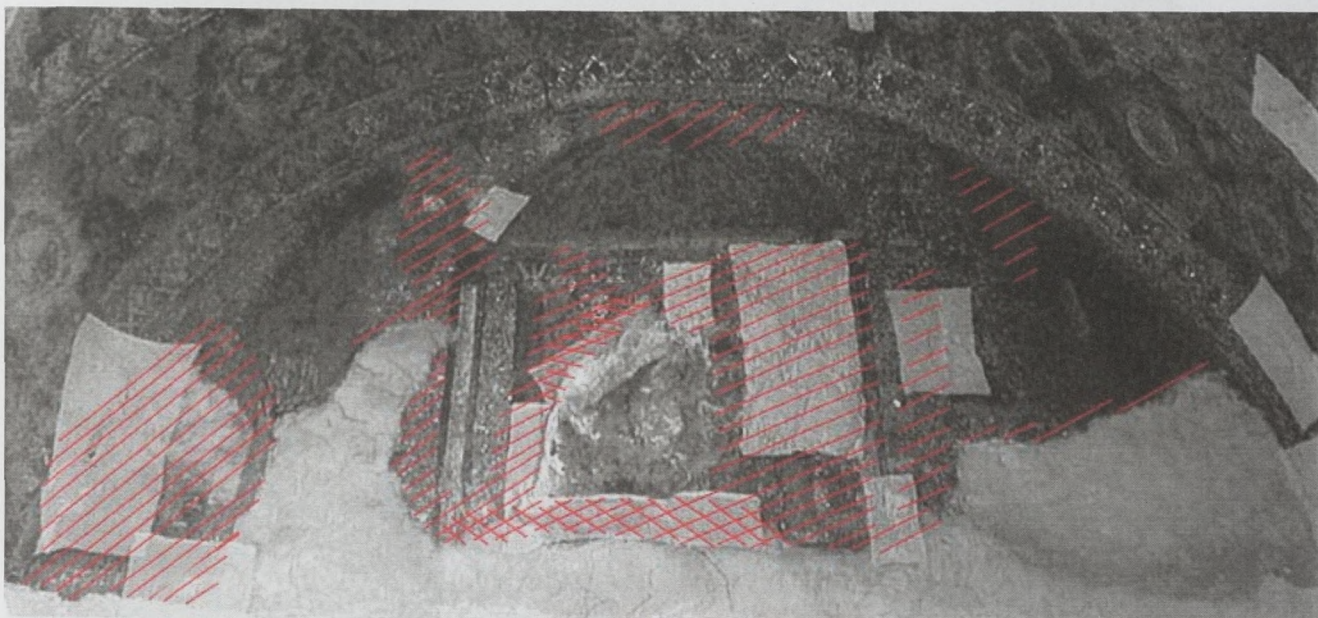
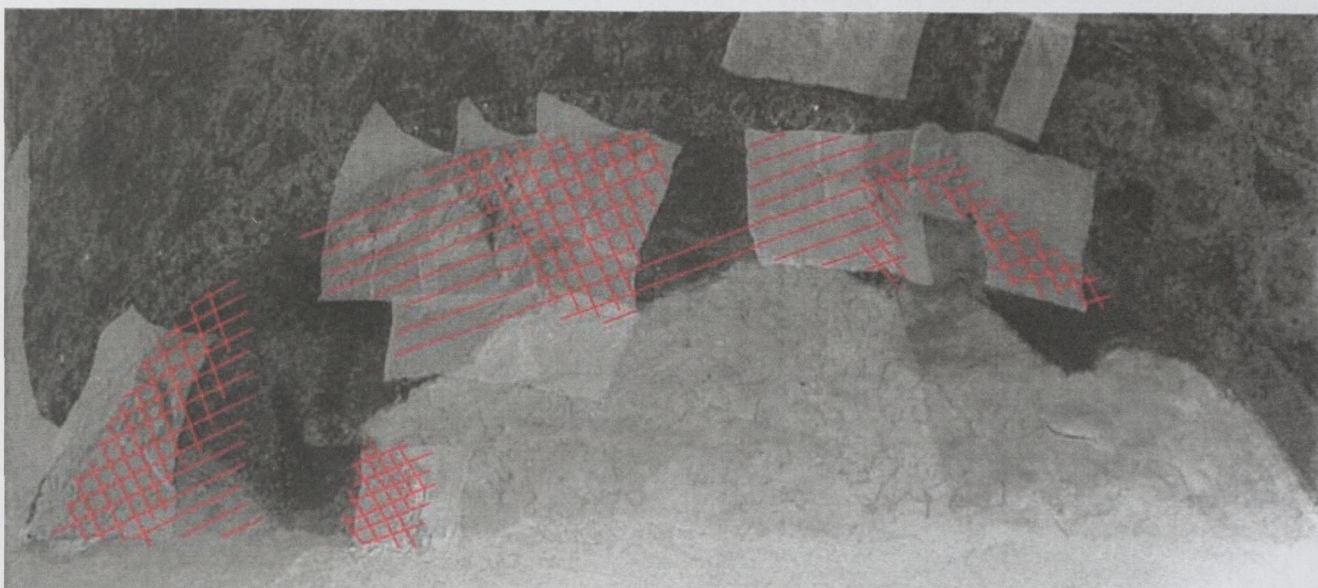
Location of areas of detachment in the north and south lunettes.

Lines: weakened areas.

Crossed lines: very fragile areas with a marked detachment from the wall.
