**REPORT ON THE STATE OF  
PRESERVATION OF THE  
BYZANTINE DU MOSAIC OF THE  
MONASTERY OF SAINT GABRIEL  
TUR ABDIN, TURKEY**

**WORKSHOP ON THE  
PRESERVATION AND  
RESTORATION OF MOSAICS  
MISSION OCTOBER 10th – 14th 2008**

## Report on the state of preservation of the Byzantine mosaics of the Saint Gabriel Monastery of Qartamin, Tur Abdin (south-west Turkey)

October 10-14, 2008

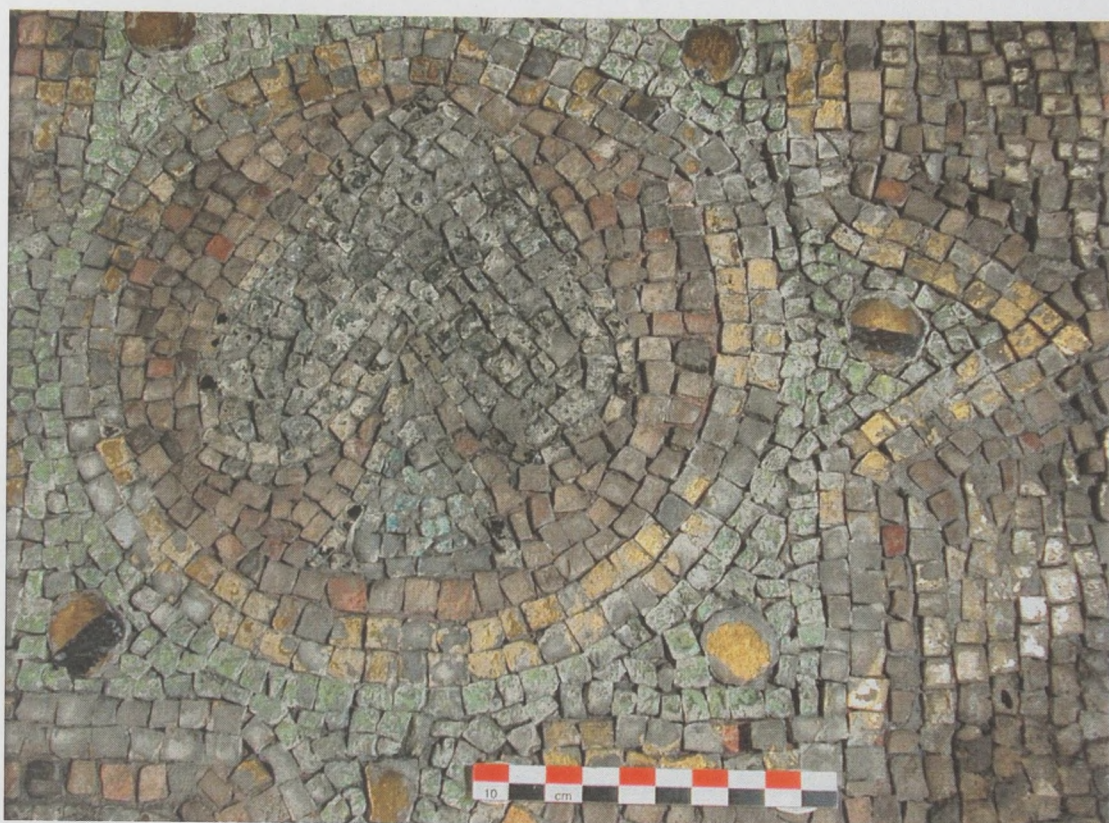
On the mosaic of the barrel vault and lunettes, which was noted in Miss Bell's first descriptions, a blackish layer has formed on the tesserae's surface. This layer is composed of chalky concretions, dust and the black smoke rising from candles and incense used in religious ceremonies, but also resulting from general sootiness, even if it seems that at some unknown date, the decor may have been dusted off. We were able to locate the part cleaned by Hawkins in 1972.

The surface of the tesserae is covered with a greyish layer of dust and soot that obscures the motifs and colors.

The general cleaning of the mosaic will essentially consist of removing the blackish deposits. These can be removed by mechanical means, for example by scalpel. Placing compresses on them can facilitate the clearing process by softening the crust when it is too hard. At the same time as these cleanings, we will also reinforce the tesserae by imbuing them with an acrylic resin solution.

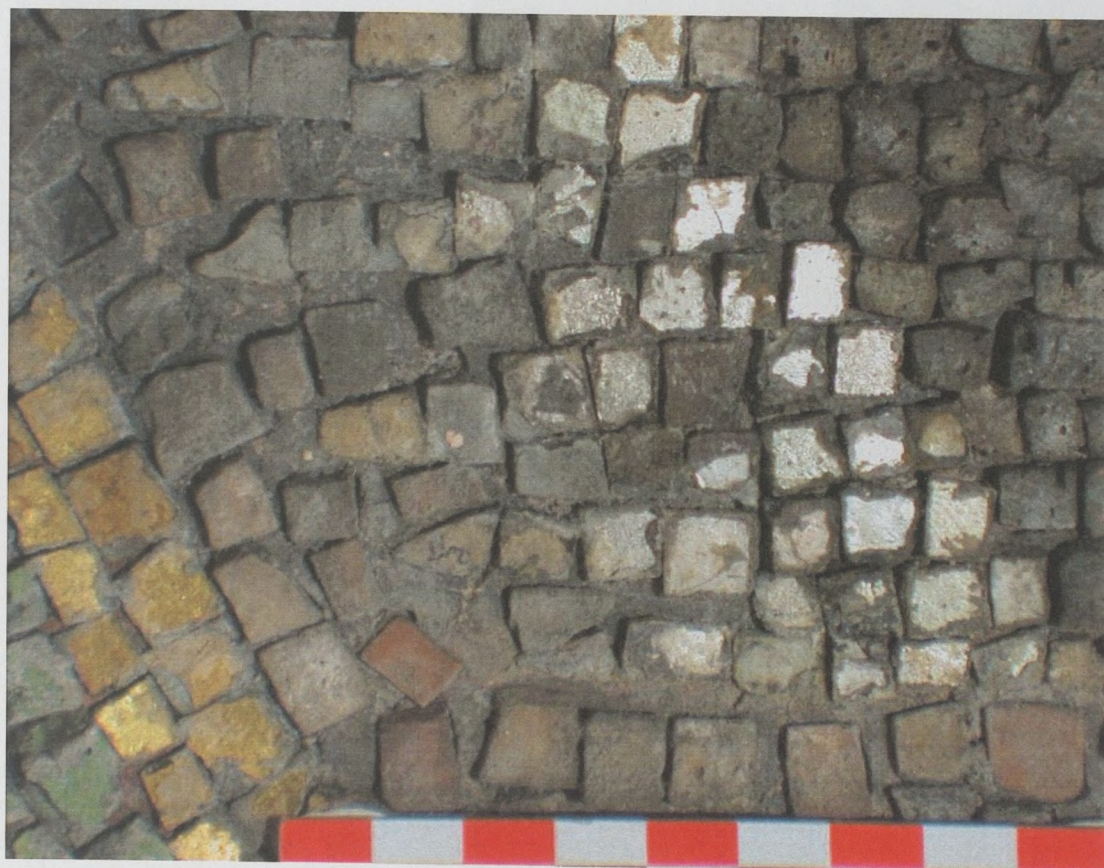
Our observations, however limited, revealed that the limestone, colored *pâte-de-verre*, and gold-leafed tesserae are in good condition. Those with silver leaf are less well preserved since the metal at the edges of the tesserae has oxidized (silver oxide). No exfoliation of the glass was noted.

The surface of the tesserae has barely changed. Only the tesserae with silver leaf show metallic oxidation at their edges (silver oxide).

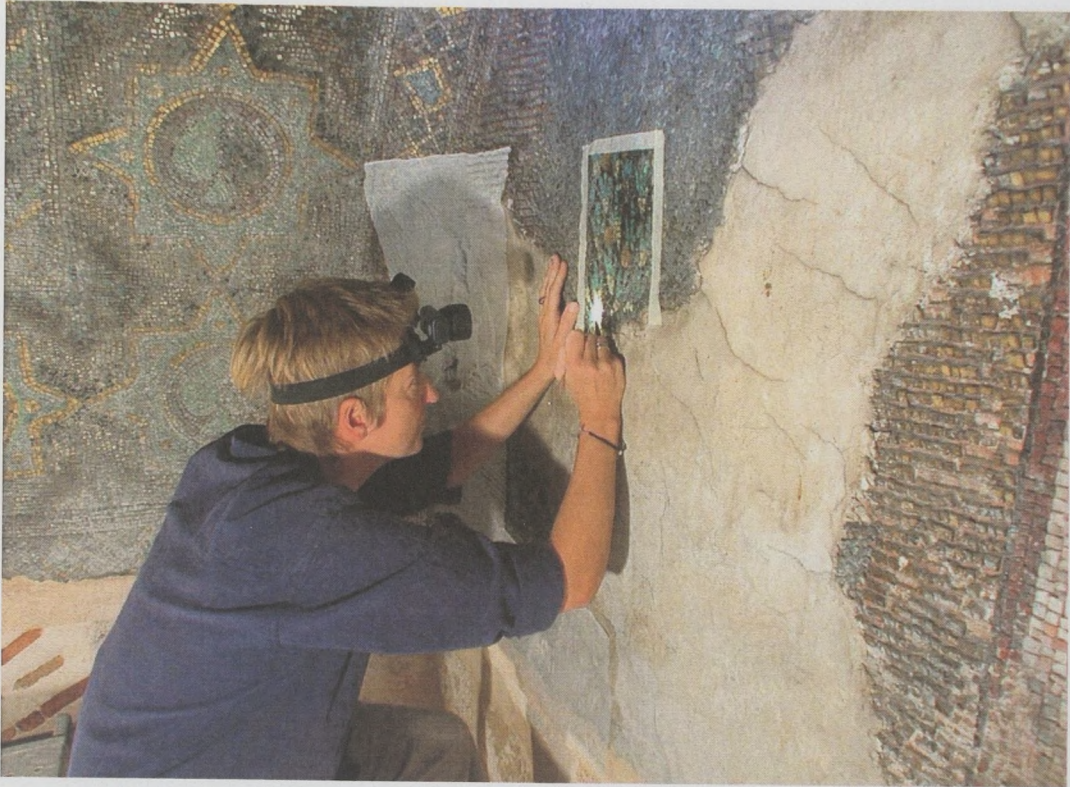
During the October 2008 mission, we conducted two cleaning tests: the first on the tree pictured on the left side of the south lunette (tesserae of colored glass and with gold-leaf), the second at the bottom of the ceiling, in the northeast corner (tesserae with gold leaf and silver leaf, glass tesserae and limestone tesserae). These tests, which were conducted mechanically (with scalpels) revealed a good overall preservation of the tesserae, except for the silver leaf tesserae.

A cleaning test conducted on the south lunette (on the foliage of the left tree) proved the surface cleaning's feasibility and efficiency.

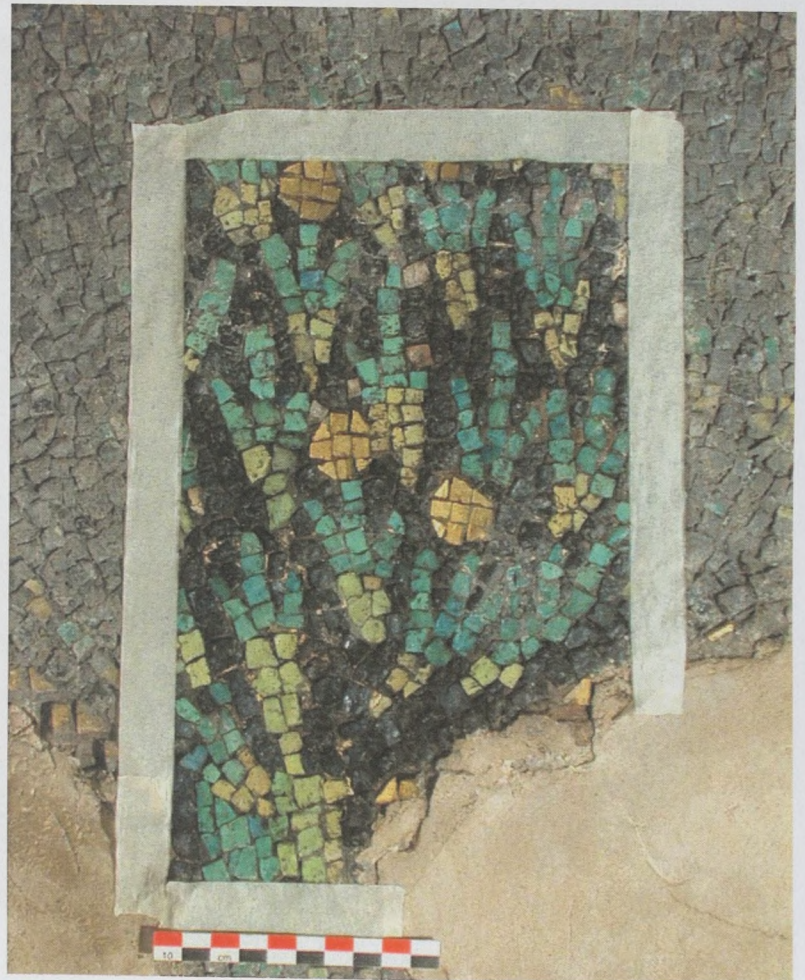
This cleaning, which was entirely mechanical, executed with a scalpel, revealed the color and shape of each tessera, bringing out the decor's brilliance.

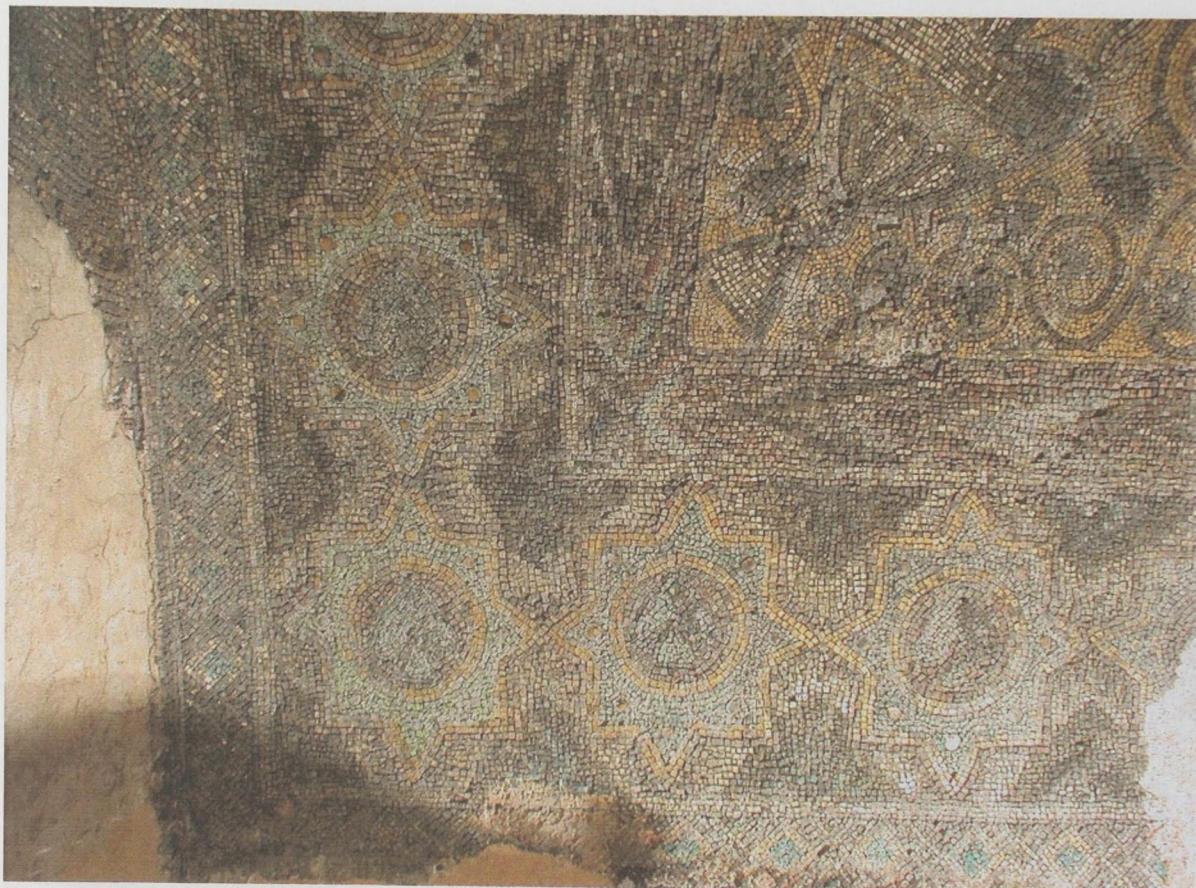
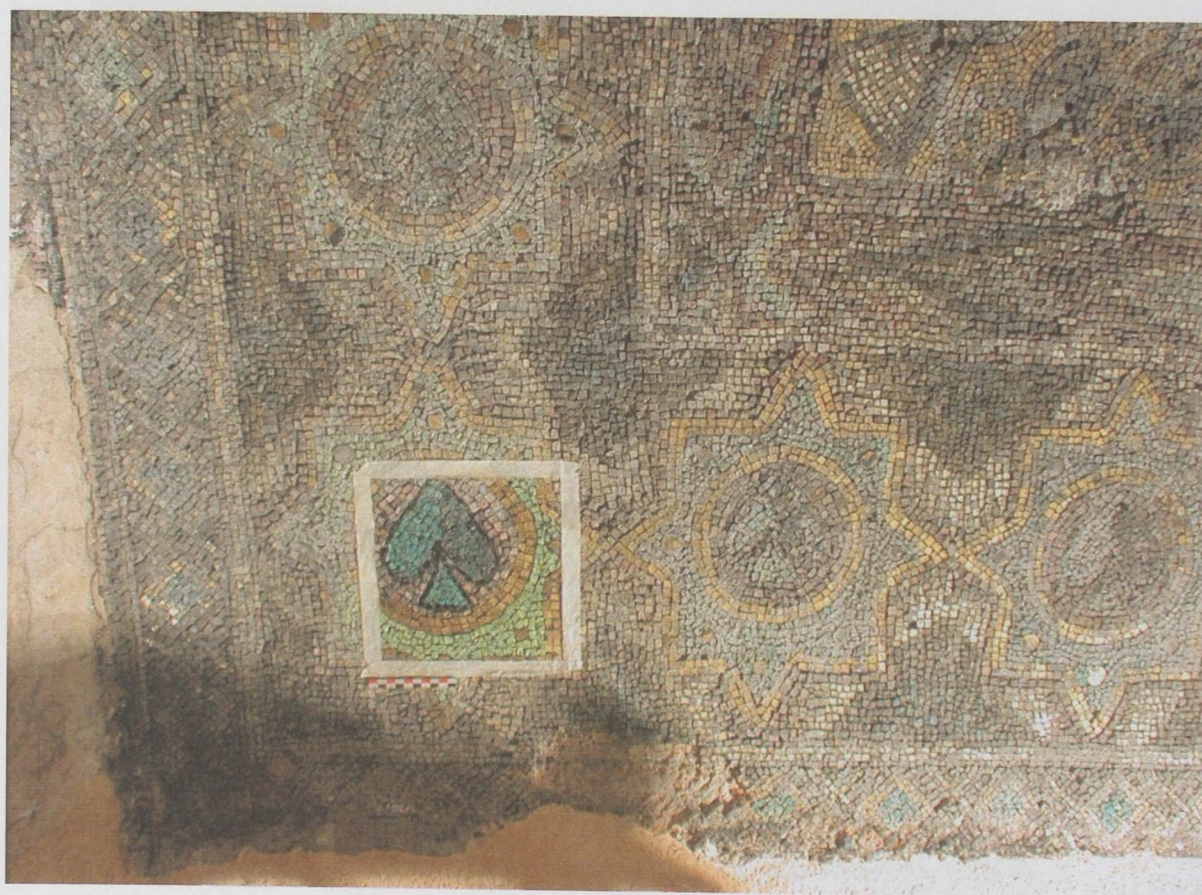
Another test was conducted on the ceiling's border, on the line of eight-pointed stars.
